# Lake Leatherwood Bike Trail Hazards

Environmental Geology

Students: Chad Hanna, Kristin Head, and Kim Oram

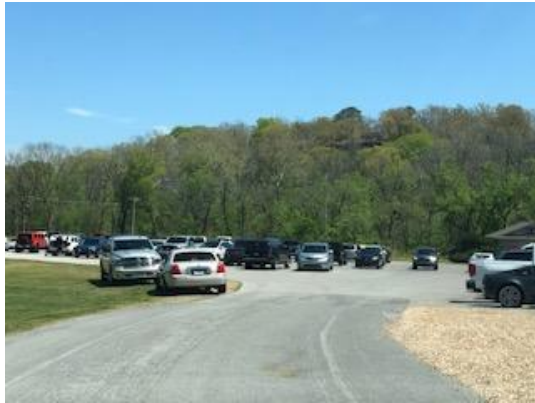
Leatherwood Trail Parking lot

To the left is Tanyard Creeks normal parking as well as their overflow parking. Both lots were full on a Thursday around 1pm.

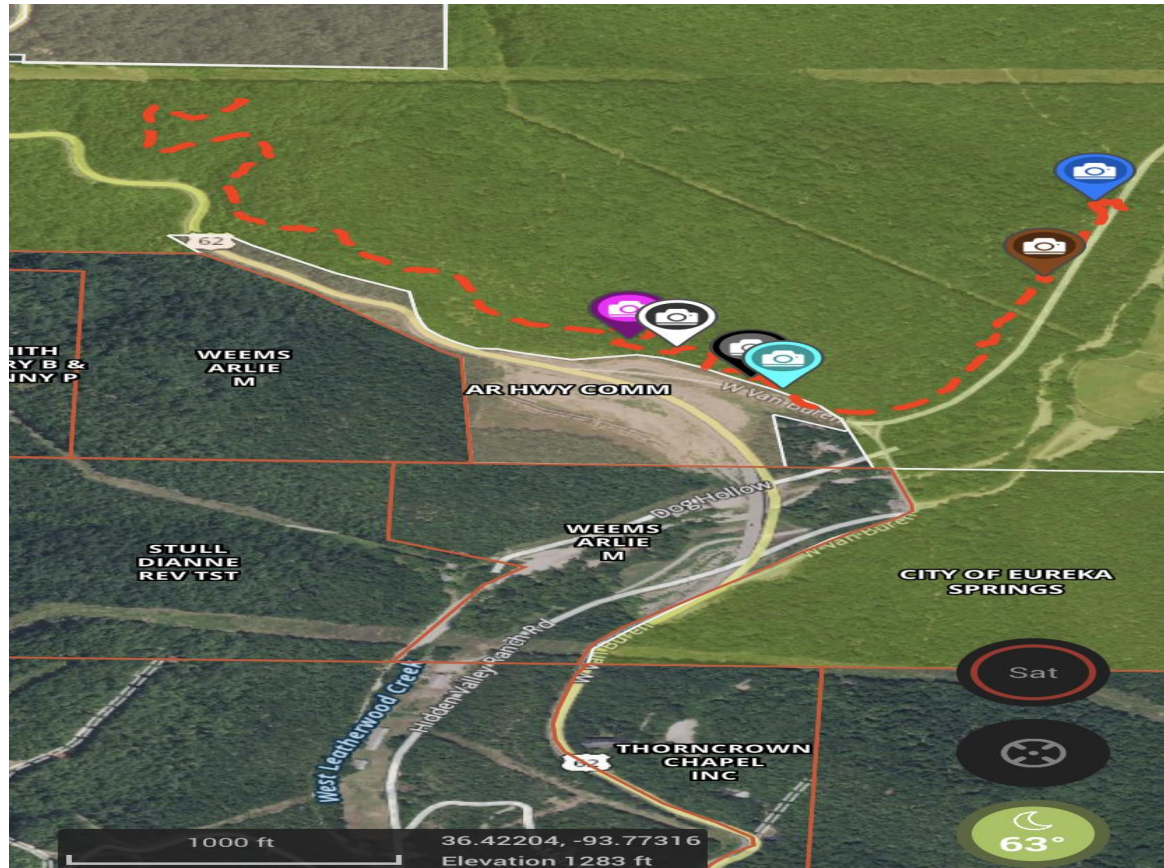
# Downhill Trail 1

**Dark Blue**- standing water- needs to be drained- coordinates (36.42616-93.76803)

**Brown**- slope wash out- slope needs to be reinforced- coordinates (36.42479-93.76854)

**Light Blue**- standing water- needs to be drained- coordinates (36.42273-93.77119)

**Black**- standing water- slope wash out- needs to be drained and stabilized- coordinates (36.42293-93.77151)

**White**- standing water- needs to be drained- coordinates (36.42348-93.77225)

**Pink**- standing water and debris- needs to be drained and debris removed- coordinates (36.42364-93.77273)

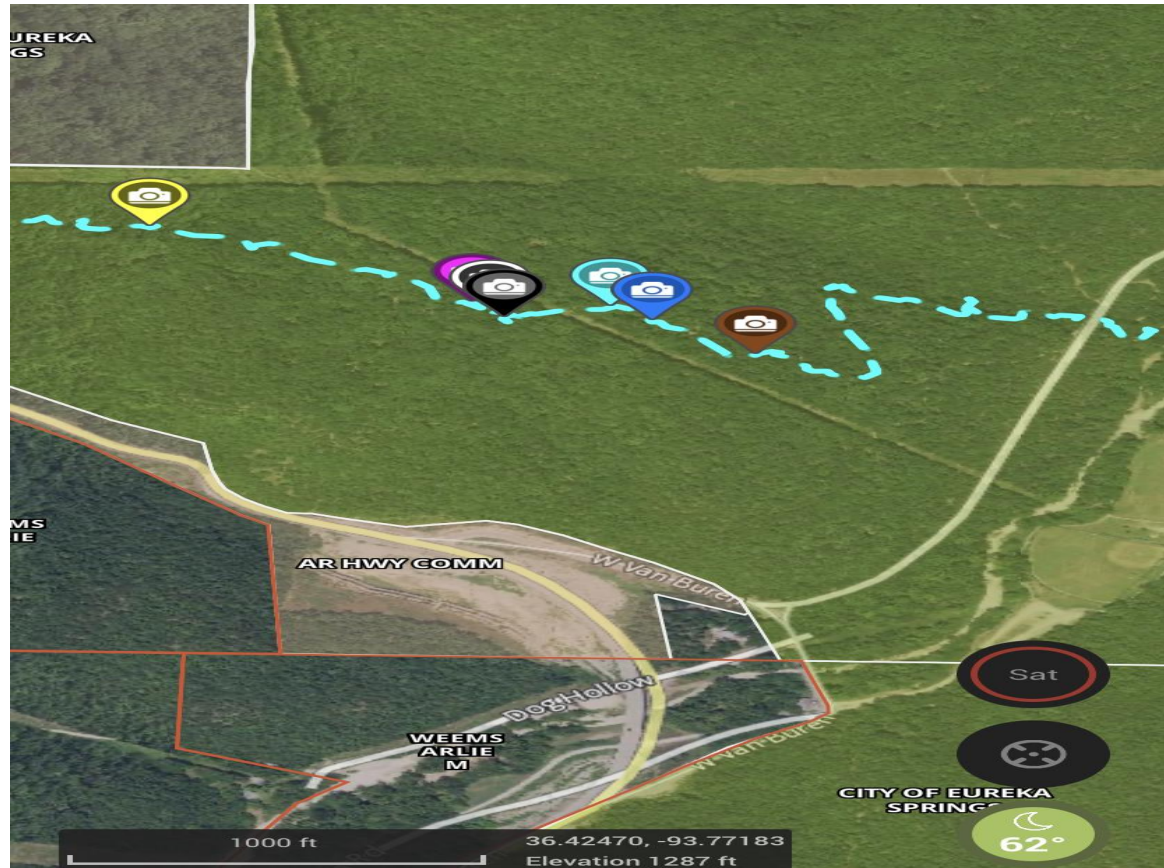
# Downhill Trail 2

**Brown**- standing water and slope wash out- needs a drain and slope reinforced- coordinates (36.42584-93.7747)

**Dark Blue**- standing water and debris- needs a drain and debris removed- coordinates (36.42634-93.77131)

**Light Blue**- standing water- needs a drain and new pitch- coordinates (36.42656-93.77165)

**Black**- sink hole in close proximity to trail- potential hazard- monitor- coordinates (36.42639-93.77252)

**White**- standing water- needs new pitch- coordinates (36.42653-93.77263)

**Pink**- standing water - needs a drain- coordinates (36.42662-93.77277)

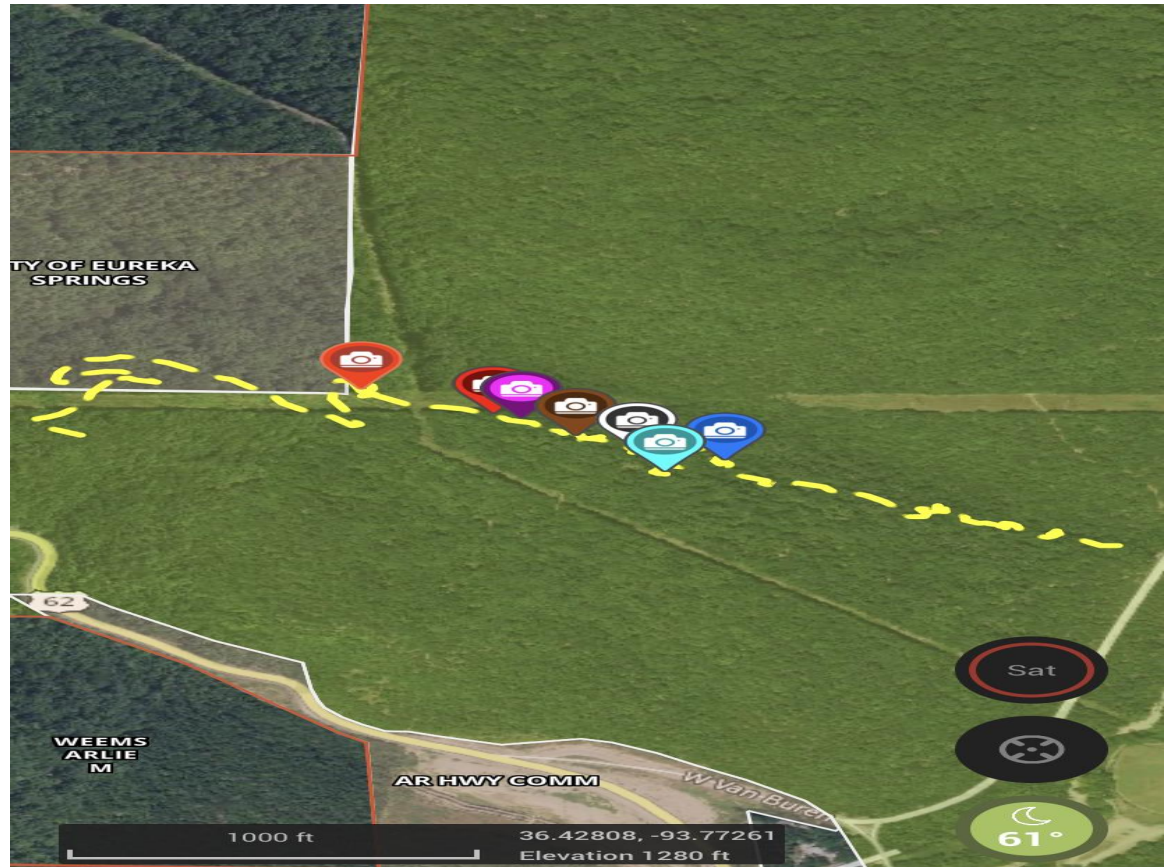
# Downhill Trail 3

**Dark Blue-** standing water- needs drain-coordinates (36.42759-93.77147)

**Light Blue-** standing water- needs drain-coordinates(36.42741-93.77196)

**White-** Standing water- needs drain and new pitch-coordinates(36.42774-93.77219)

**Brown-** Slope washout- slope needs reinforced- coordinates( 36.42796-93.77270)

**Pink-** Standing water- needs drain- coordinates ( 36.42822-93.77270)

**Red-** Standing water- needs drain- coordinates ( 36.42829-93.77338)

**Orange-** Standing water- needs drain and new pitch-coordinates ( 36.42866-93.7748)
