Hazards of The Greenway

By Matthew Morehart
Instructor: Paul Lowery GEOS 2943 & Dr. Galloway
BOTY 2534-02Y
Northwest Arkansas Community College

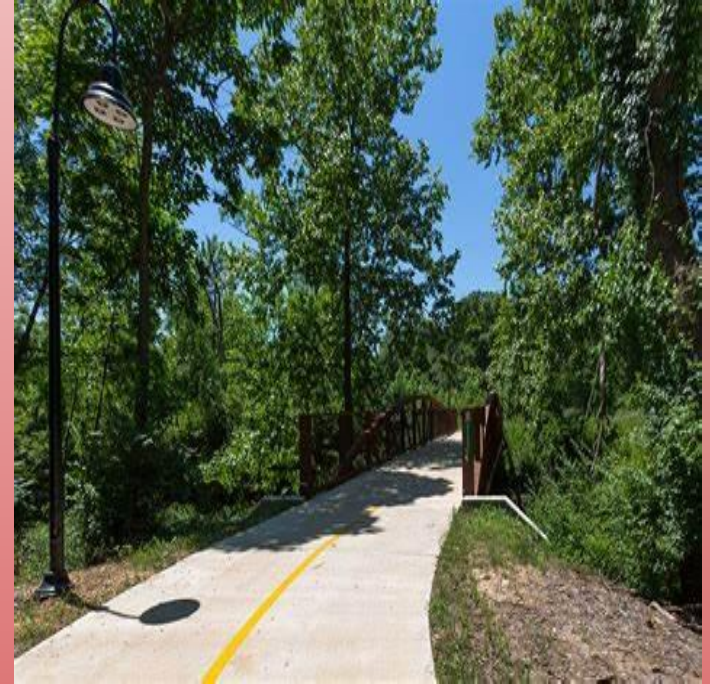
The greenway trail is a 40 mile, beautiful trail that stretches through 6 towns: Rogers, Bentonville, Bella Vista, Lowell, Springdale, and Fayetteville. It consists of both off-road and paved trails that connect schools, businesses, and cultural amenities. The trail is used for families, cyclist, runners, and walkers. It runs alongside multiple streams. Though this trail is a beautiful place for families and community members to gather and spend time, it has many structures in need of maintenance. There are also pollution issues, flooding issues, and the trail itself suffers from breakage and roots growing under the trail .

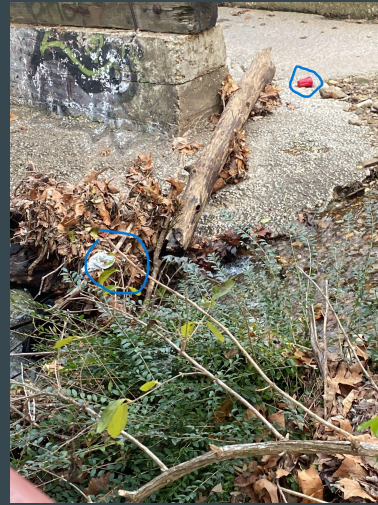
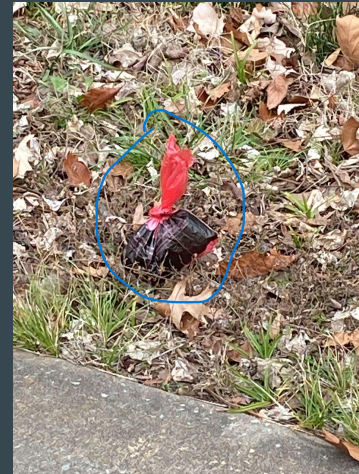
- 42 of 54 surveys completed involved pollution along the trail.
- Most of the sets are in close proximity to each other in small groups. These pockets of trash were around high homeless populations.
- As seen in the pictures, trash is tossed along the trails, and a lot of it ends up into the streams. A few of these streams stem from Beaver Lake, water sources for the city's drinking water after filtration
- During this 8 mile stretch, I found that only 2 trash-cans were available.

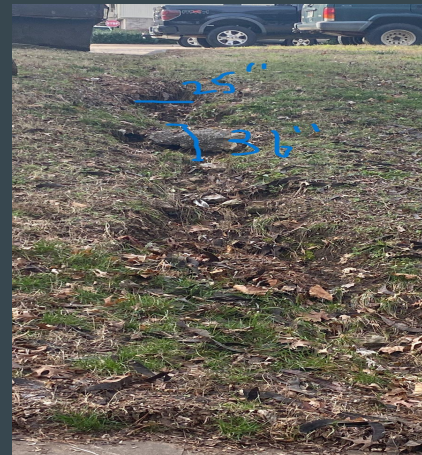
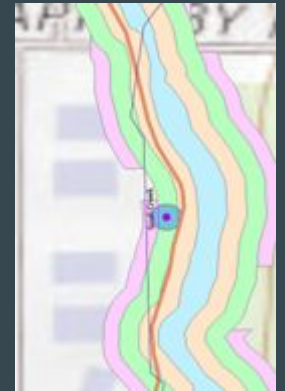
- Washouts were the main focus after the collection of trash.
- These washouts were measured by depth and width with a small measuring tape I carried.
- Though most washouts were relatively small ones, they definitely caught my eye. There was a washout coming from a parking lot above the trail, which could pollute the stream below with oil and/or other chemicals. This could be hazardous to the ecosystem surrounding the stream as well as the wild life.
- This washout was over 24 inches wide and 36 inches deep and had already begun to wash away underneath the trail causing a potential for the trail to cave-in.
- Using select by attributes I created a single layer of washouts.

-By using the buffer tool, I then created a 20ft buffer around washout and added data showing the elevations by unique values. The particular washout shown was below a stream and normally is a flooded area along the trailside.

By using Survey123 and ArcGIS mapping tools such as Buffer, select by attributes, select by locations, downloading shapefiles, creating a feature layer, creating a domain, and creating a layout view, I was able to produce a detailed map for easy reference. This map should be used to help fix hazards, to create more possible areas for trash cans, to reduce pollution, and to find a way to divert washouts away from the trails or build wall barriers to protect the structure of the trails.

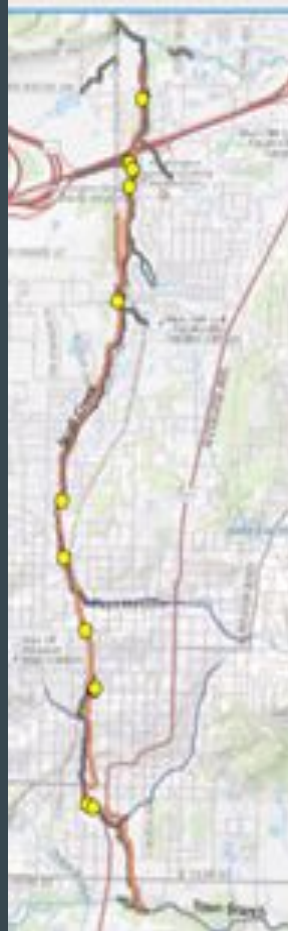
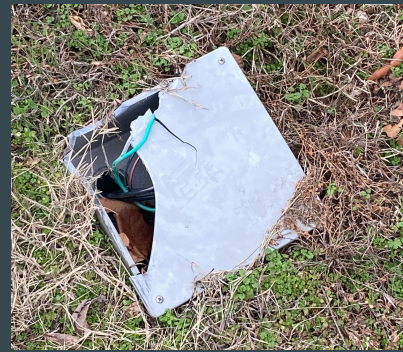
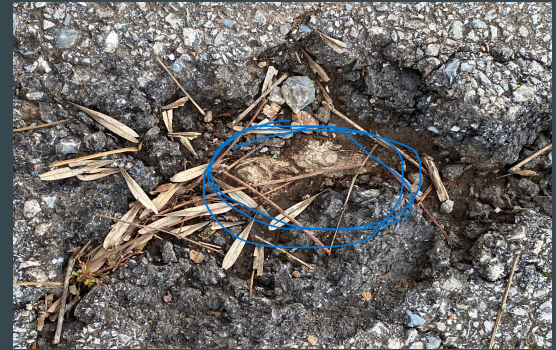
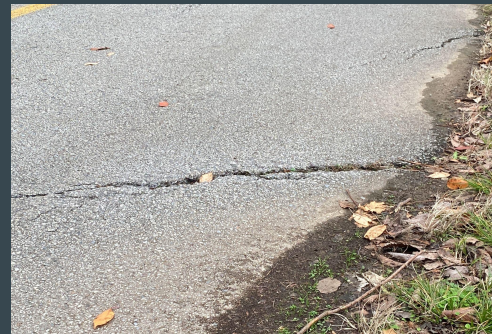
-Next were the structures in need of maintenance. There were multiple lamp posts in need of new covers because the existing covers were exposing open wiring.

- One electrical box had been broken and wires were hanging out causing possible hazards for children that walk along the trail as well as possible dangerous situation from night walkers that need these lamps to feel safe.

-Another thing found in need of maintenance was the trail itself. There were multiple examples of this including washouts, roots growing underneath the trail causing small raised portions of the concrete, and the natural settling of the concrete.
