# Lake Leatherwood Bike Trail Hazards

Environmental Geology

Students: Chad Hanna, Kristin Head, and Kim Oram

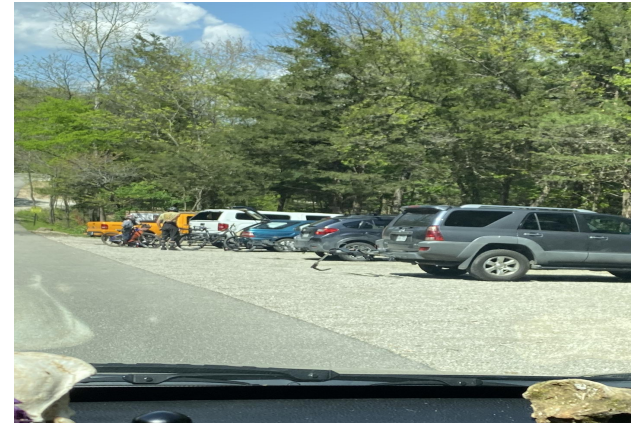
To the left is Tanyard Creeks normal parking as well as their overflow parking. Both lots were full on a Thursday around 1pm.
